HYDRAULIC MODEL STUDIES OF
WEBSTER DAM SPILLWAY

Hydraulic Laboratory Report No. Hyd-390

Subject: Hydraulic model studies of Webster Dam Spillway

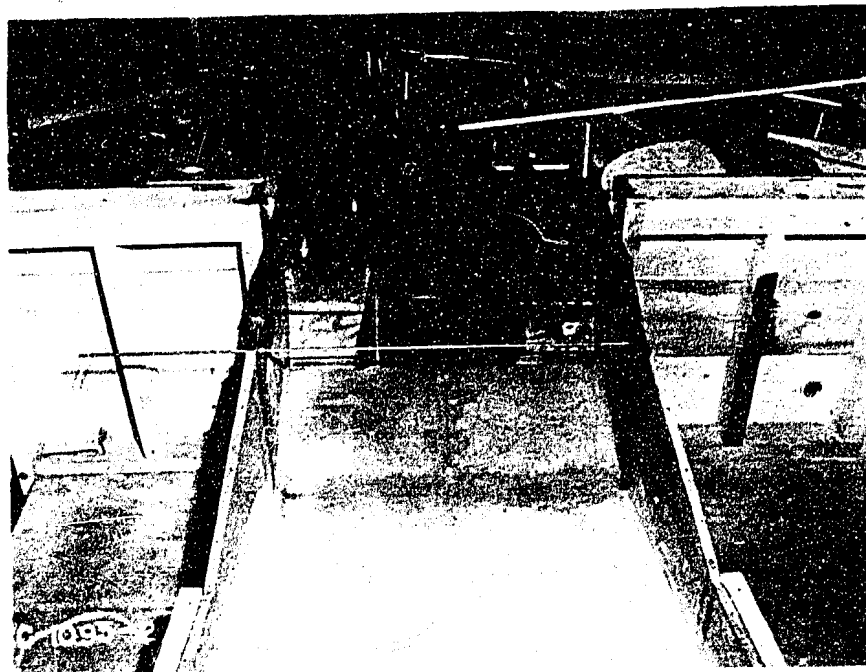
A. Note model gates and wood contours

WEBSTER DAM SPILLWAY
Model Construction
1:54 SCALE MODEL

wooden templates shaped to the ground surface contour as shown in Figure 10. Model concrete surfaces simulating nonconcrete surfaces of the prototype, such as topography, were given a rough finish while concrete surfaces simulating concrete surfaces in the prototype were given a smooth finish. Topography in the downstream area was formed in sand in order to provide a movable bed in which to study the erosion characteristics of the flow leaving the structure.

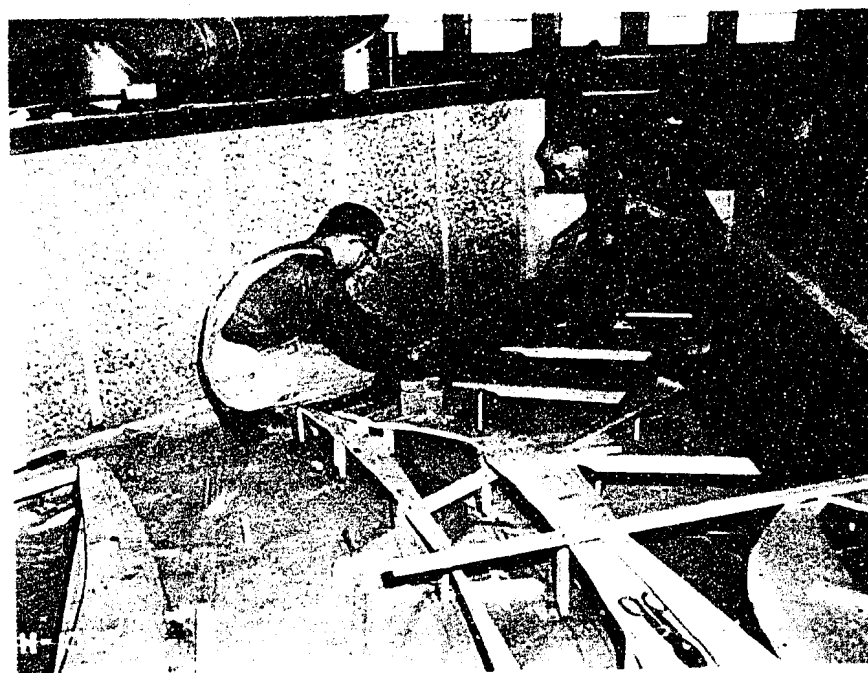
B. Note wood contours being covered with metal lath

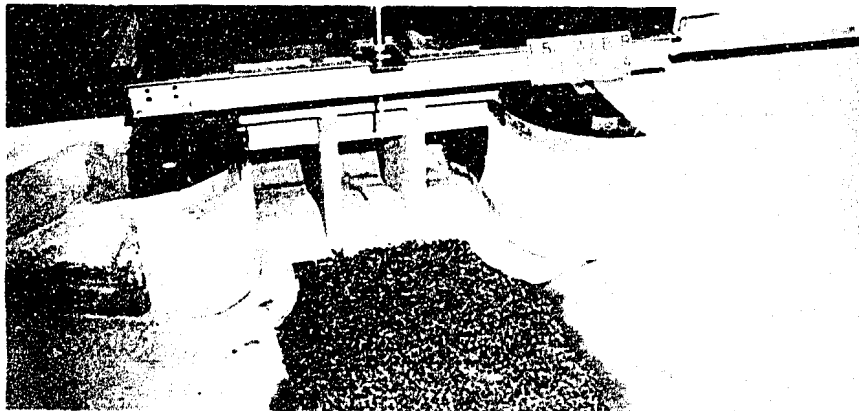
A. Preliminary inlet walls and water surface point gage

WEBSTER DAM SPILLWAY
Flow Through the Preliminary Spillway Entrance--136,000 Second-feet
1:54 SCALE MODEL

The model of the spillway approach area with the preliminary inlet wall design is shown in Figure 12(A). Figures 12(B), 12(C), and 12(D) show 136,000 second feet approaching, entering, and passing through the gate section. The flow approached the spillway quite satisfactorily for all discharges; however, the flow piled up on the pier noses as shown in Figures 12 and 13 and the water surface was drawn down around them for discharges near maximum. This was a matter of interest however, rather than concern.

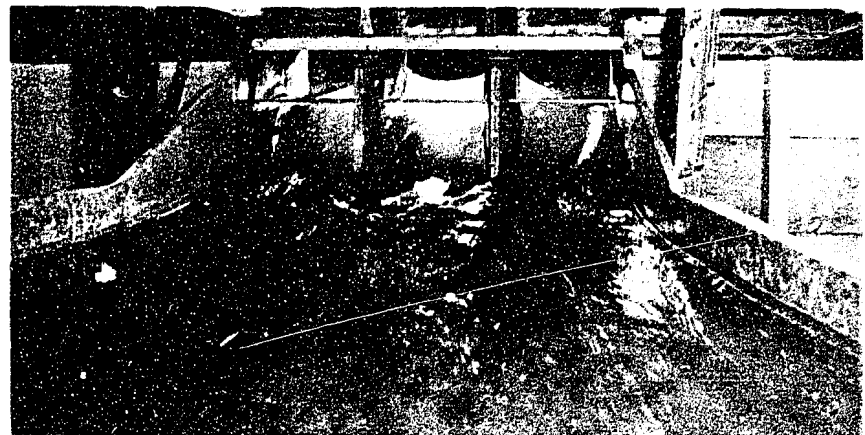
D. Flow leaving gate section

Flow through the gate section is shown in Figure 12(D) for the design discharge of 136,000 second feet and in Figure 11(B) for 11,000 second feet through a 3-foot opening of the gates. Flow around the trailing edge of the piers was satisfactory. Motion pictures of the flow through the gate section were made for the design discharge.

Flow entering the chute is shown in Figure 11(B) for 11,000 second feet with the gates open 3 feet and in Figure 12(D) for the design discharge of 136,000 second feet. Figure 21 shows the flow through the chute for the design discharge. A standing wave occurred on the center line of the spillway chute a short distance downstream from the gate section as shown in Figure 21(C) and others occurred as shown in Figure 21(D); however, the flow entered the stilling basin fairly uniformly distributed from one training wall to the other as shown in Figures 21(A) and (B). For 136,000 second feet the flow entering the basin was slightly more concentrated near the center of the chute as shown in Figure 22. For all lesser discharges the flow in the chute was fairly uniform from one training wall to the other before entering the stilling basin. This good distribution was instrumental in providing the good action observed in the stilling basin. The flow distribution appeared to be satisfactory also for gate-controlled flows if the openings of the three gates were symmetrical.

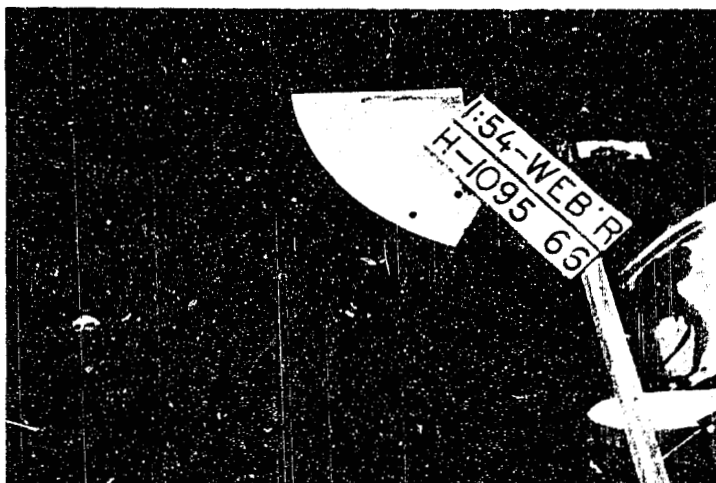
B. Design 1--136,000 second-feet. Note absence of drawdown

Flow along the preliminary inlet walls was very smooth even for the maximum design discharge as shown in Figure 12(B), but it was decided by the designers to test four alternate inlet wall designs that were more economical for prototype construction. All four alternate designs operating with the maximum discharge of 136,000 second feet are shown in Figures 14 and 15. Design No. 3 was the most economical design to construct, but the drawdown around the vertical portion of inlet wall was considered to be too great; therefore, the second most economical structure shown as

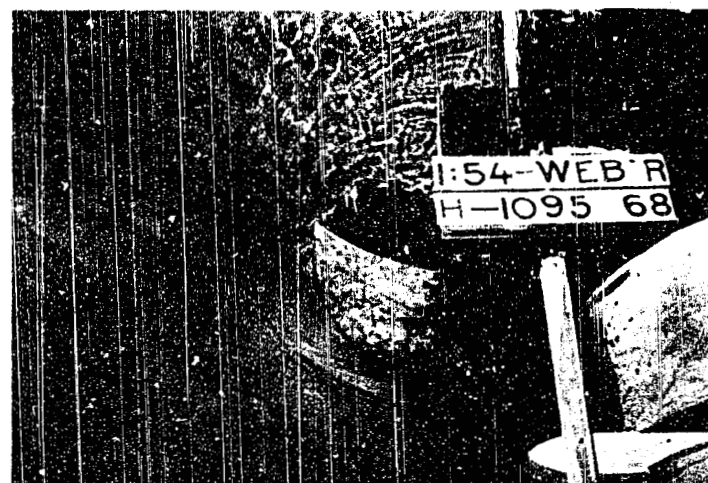
D. Design 2--136,000 second-feet. Note excessive drawdown

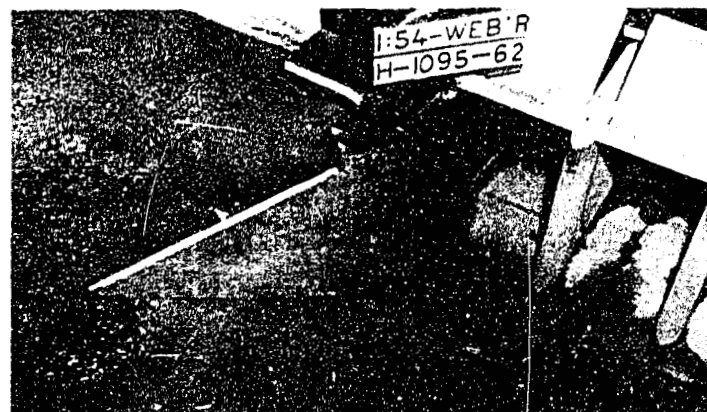
C. Design 4--Recommended

D. Design 4--136,000 second-feet. Note disturbance but not excessive drawdown

Design No. 4 was adopted by the designers for prototype construction. This design caused some disturbance along the sloping walls for discharges near maximum, but tests showed that this disturbance did not reduce the capacity of the spillway. Motion pictures of the design flow along the recommended inlet walls were taken.

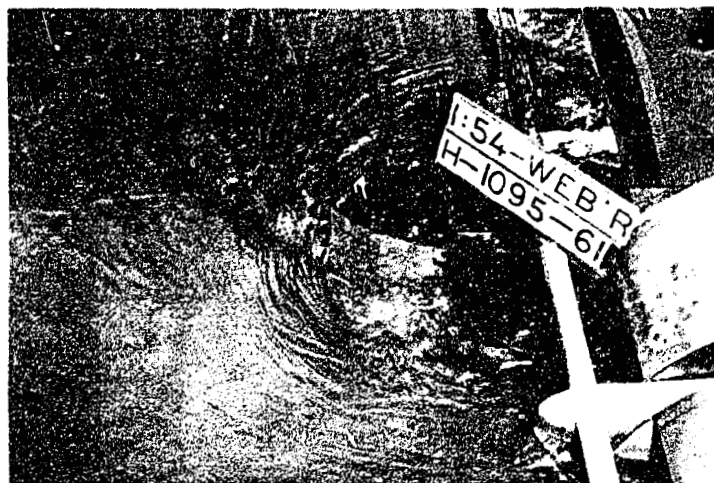
B. Design 3--136,000 second-feet. Note disturbance and drawdown

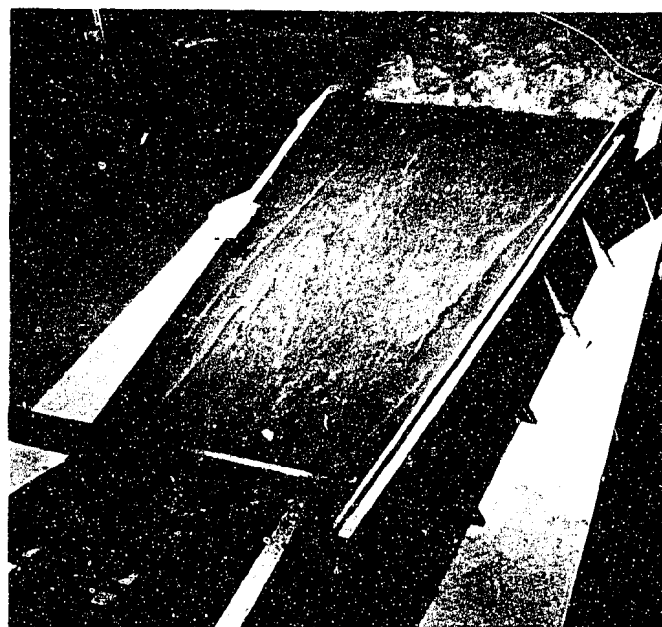
D. Note standing waves

WEBSTER DAM SPILLWAY
Flow Through the Chute--136,000 Second-feet
1:54 SCALE MODEL

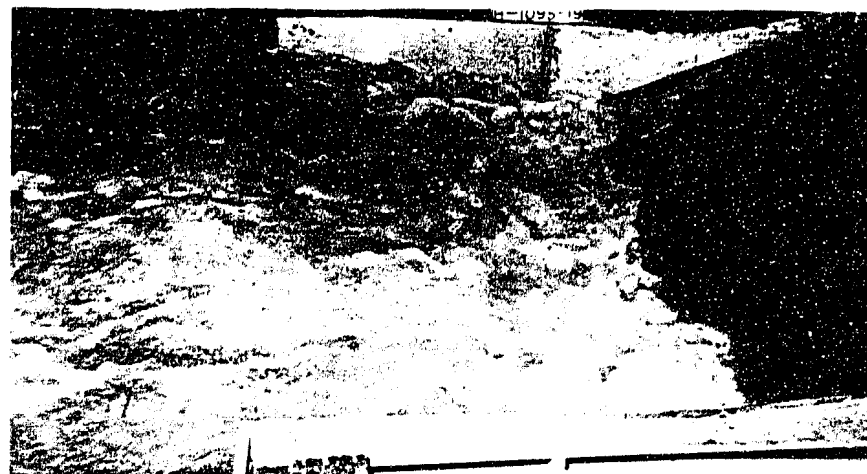
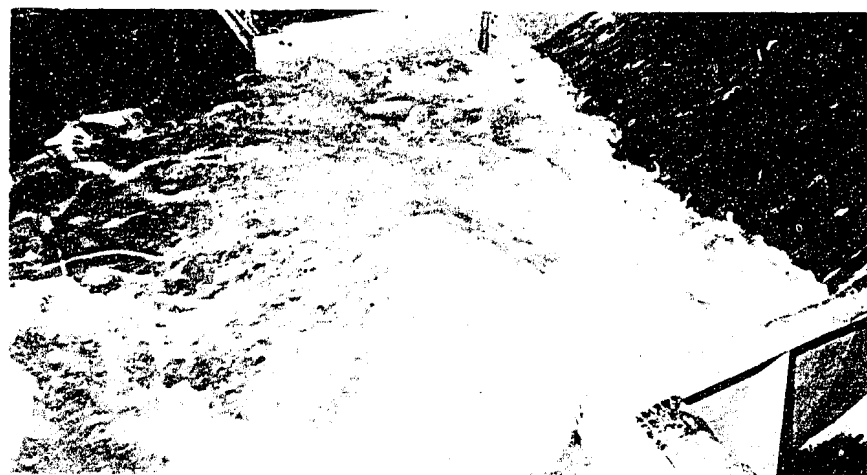
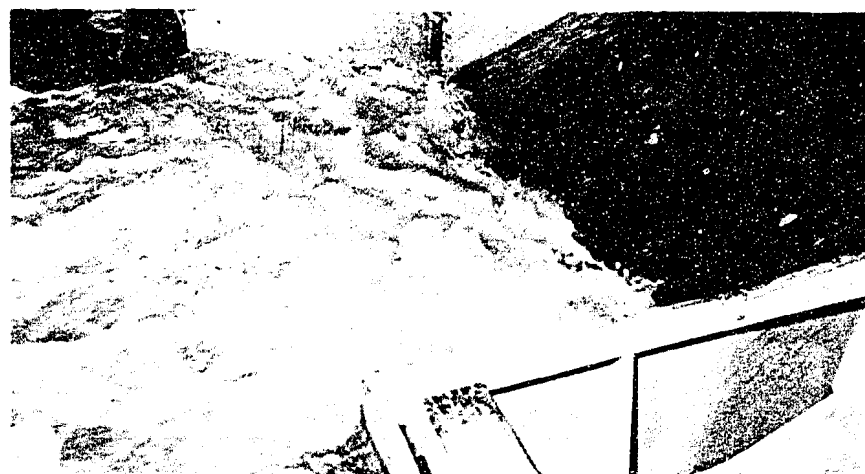
A. Normal tail water elevation

B. Tail water elevation 2 feet below normal

C. Tail water elevation 4 feet below normal

WEBSTER DAM SPILLWAY
Preliminary Basin Discharging 136,000 Second-feet
1:54 SCALE MODEL

The factor of safety between the expected tail water elevation and the elevation at which sweep out occurred appeared to be more than ample; about 11 feet at maximum discharge and increasingly more than 11 for smaller discharges. In fact, it was necessary, in conducting the tests, to lower the elevation of the discharge channel in order to lower the tail water sufficiently to cause the sweep out.

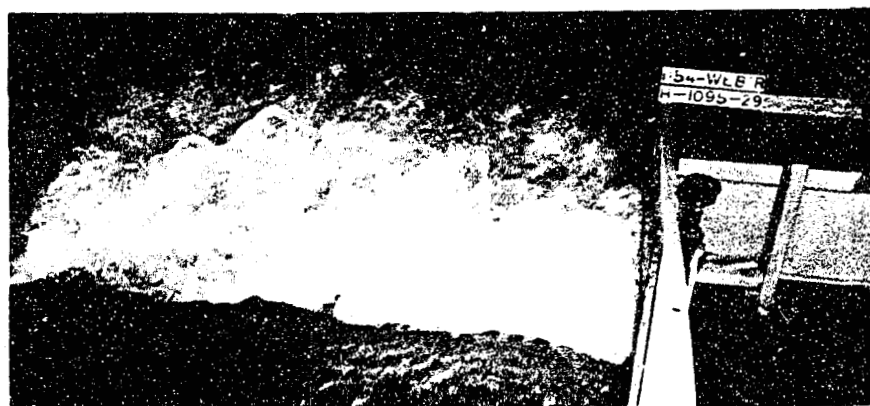
A. Preliminary basin. Normal tail water

B. Preliminary basin-tail water elev. 4 feet
below normal

WEBSTER DAM SPILLWAY
Preliminary Basin Discharging 136,000
Second-feet
1:54 SCALE MODEL

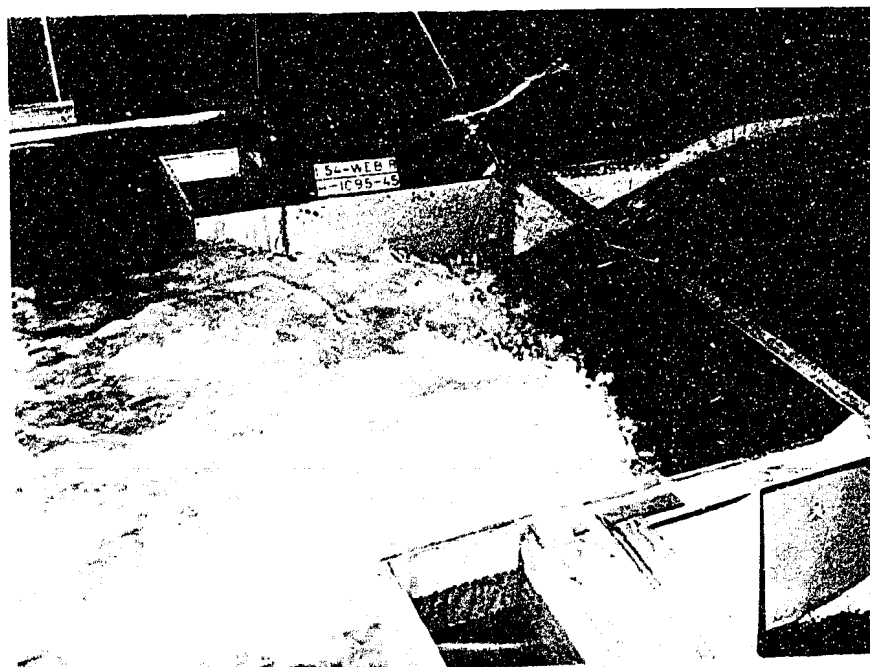
FIGURE 28
Report Hyd-390

A. With chute blocks

B. Without chute blocks

Note: Tail water depth is the same for A & B

WEBSTER DAM SPILLWAY
Stillling Basin With and Without Chute Blocks--136,000 Second-feet
1:54 SCALE MODEL

The necessity for chute blocks on the apron was determined as shown in Figure 28. Figures 28(A) and (B) show a basin operating with and without the blocks. The blocks were found to be a real aid in helping the jump to form well upstream in the basin and in increasing the stability of the jump.

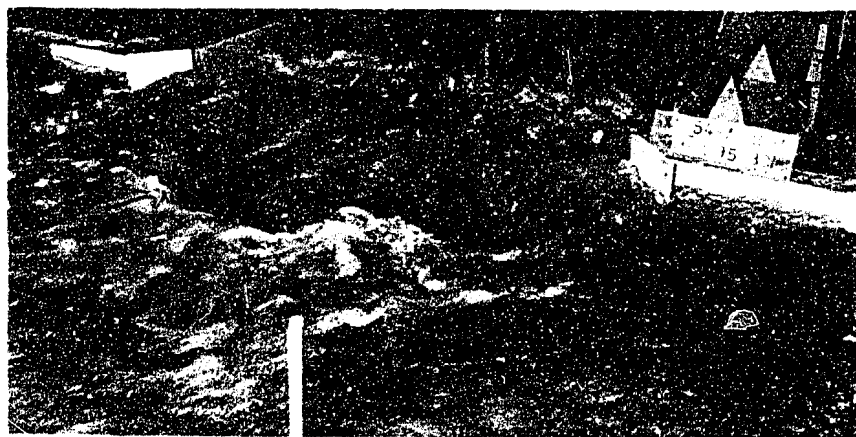
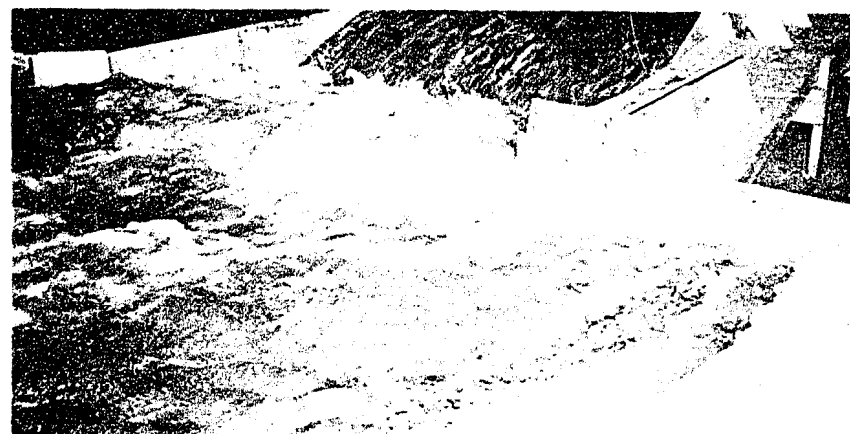
A. The six slots nearest training wall are filled in to sill height. See Figure 8

B. Scour pattern after 30 minute model erosion test. Note absence of erosion along end sill

C. Note boil over end sill

D. Boil is highest over the filled in slots

WEBSTER DAM SPILLWAY
Performance and Erosion Tests on Recommended Stilling Basin--136,000
Second-feet
1:54 SCALE MODEL

The recommended design included the 45° corner training walls and relocation of the preliminary 90° wing walls 12 feet upstream from the end of the basin, plus one further modification of the end sill as shown in Figures 8 and 33. The slots between dentates at each end of the sill were filled in to sill height and fillets were added to the sill at the downstream corners to conform to the slope of the channel banks. The slots were filled in at each end of the sill as far out from the training wall as erosion along the sill occurred in the preceding test described above. Six slots on each end were therefore filled; a distance of 64.5 feet out from the training wall.

closely. The area that was riprapped is shown in Figure 35(A) and was partially determined by noting the eroded areas evident in the erosion test in sand, Figure 33(B). The initial 2-hour test run showed no movement of riprap to occur along the end of the structure, Figure 35(B). Even on the side slopes along the 90° wing walls the riprap did not move as did the sand without the riprap protection. The downstream portion of the left bank failed, however. The cause was determined to be insufficient thickness of riprap in the model test or insufficient packing of the sand underneath because a repeat test did not disclose this failure. However, the initial test did indicate that the waves from the boil at the corners of the basin may cause riprap failure of the prototype channel banks if the thickness of the riprap layer is not sufficient. The repeat test shown in Figure 35(C) was an 8-hour test, 2 hours of which was with 1/4 maximum flow, 2 hours with 1/2, 2 hours with 3/4, and the final 2 hours with full maximum discharge. None of the riprapped areas failed in this test. Some of the riprap along the end of the structure was covered with sand but the riprap, in general, was not dislocated.

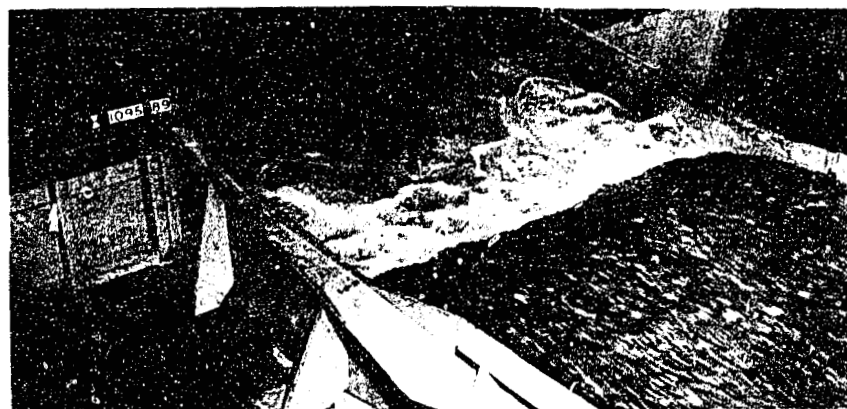
A. 1/4 maximum discharge, 34,000 second-feet.
Flow distribution in basin is not uniform

B. 1/2 maximum discharge, 68,000 second-feet

C. 3/4 maximum discharge, 102,000 second-feet

D. Maximum design discharge, 136,000 second-feet

WEBSTER DAM SPILLWAY
Flow Distribution in Recommended Stilling Basin
1:54 SCALE MODEL

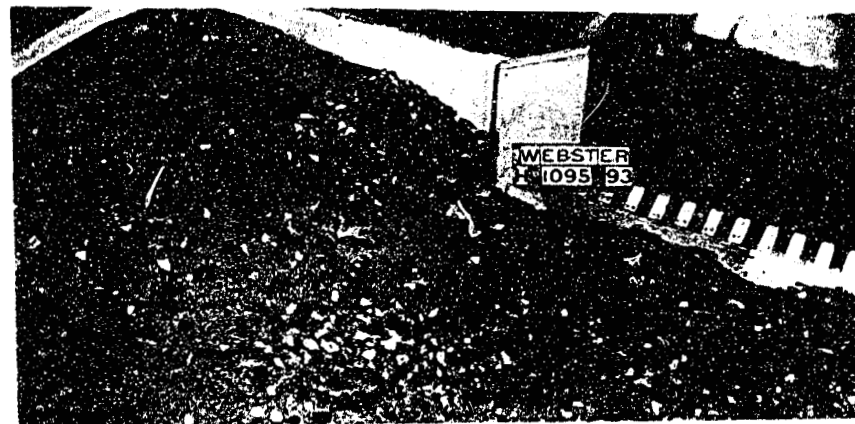
A. Discharge channel prepared for erosion tests

B. Scour pattern after 2 hour model erosion test, 136,000 second-feet. Note failure of left bank riprap

C. Scour pattern after 8 hour model erosion test. 2 hours $1/4$ maximum flow, 2 hours $1/2$ maximum flow, 2 hours $3/4$ maximum flow and 2 hours at maximum. Note no failure of bank riprap

D. Test in (C) continued 4 more hours with maximum discharge. Note right bank riprap failed

WEBSTER DAM SPILLWAY
Recommended Stilling Basin Erosion Tests
1:54 SCALE MODEL

An additional 4-hour test with maximum flow continuing from where the previous 8-hour test left off finally produced a gradual failure of the riprapped area on the downstream portions of the right bank as shown in Figure 35(D). One hour, model, is equivalent to 7.3 hours, prototype. The results of these tests were considered satisfactory by the designers, therefore, this basin was recommended for prototype construction.
